Report Date 10/2/2008

Company Springs Thermal Imaging

Thermographer Todd McClintic

Site Address 123 Tejon Ave.

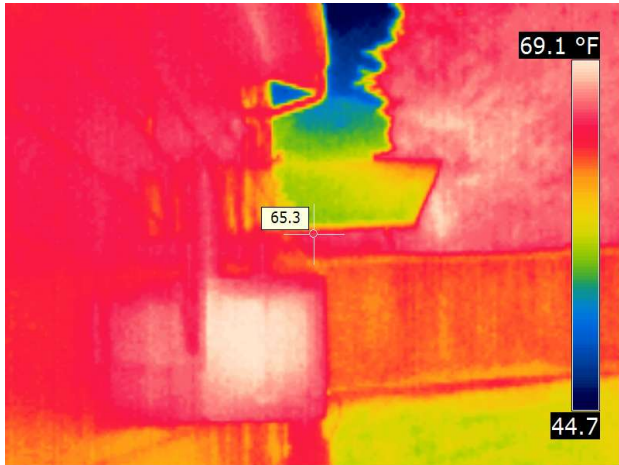
Description
This image shows the heat loss from a window swamp cooler. Removing this unit should stop heat loss

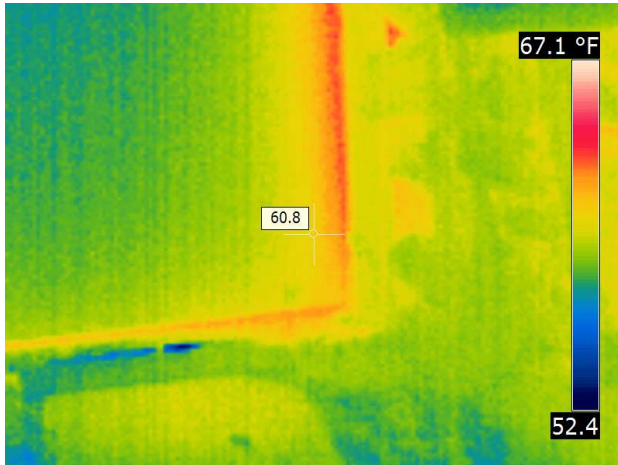
Description
This image shows the heatloss from an exterior door to the residence. Replacing the weather stripping should help prevent air from escaping around the door jam.

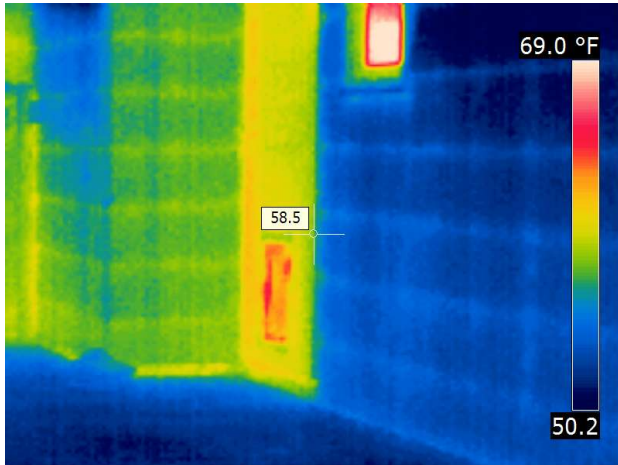
This photo shows the heat loss coming from an installed dog door. As the temperature drops outdoors, the homeowner should make sure that the storm door behind this one remains closed.

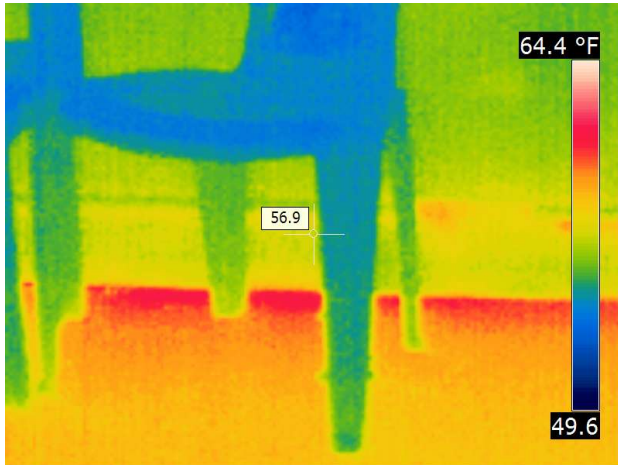
This photo shows the heatloss coming from behind the siding on the house. This heat appears to be coming from a window that has been sided over.

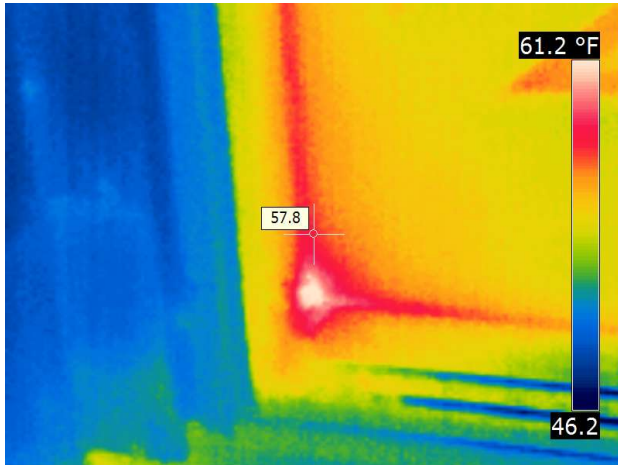
This image shows that there has been damage to the bottom of this door that is letting heat escape. By replacing this door and making sure that the replacement has adequate weather stripping, substantial heat loss can be prevented.

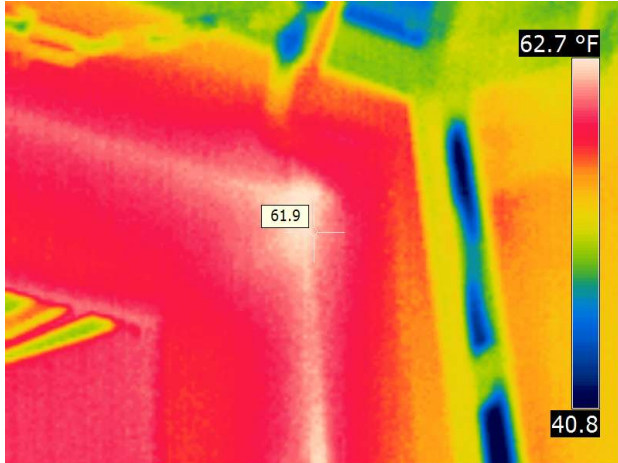
Description
Heat loss due to inadequate weather stripping on the east side exterior door.

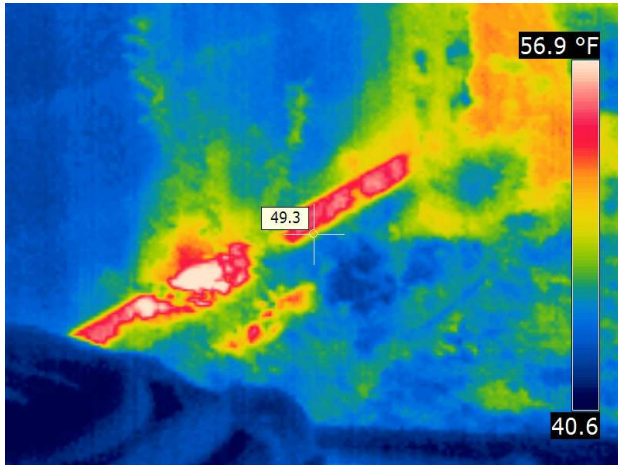
This photo shows the heat loss coming from a crawlspace vent under the house. By covering this vent up during the winter months, substantial heat loss can be prevented.

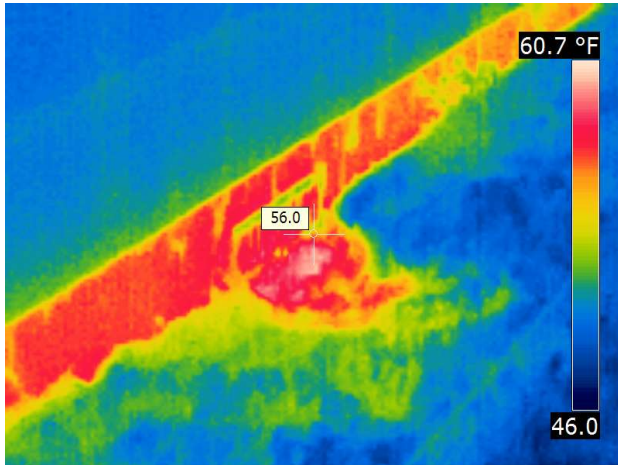
Description
Heatloss from the north facing crawlspace vent. Again covering this vent with insulating foam will prevent heat loss.

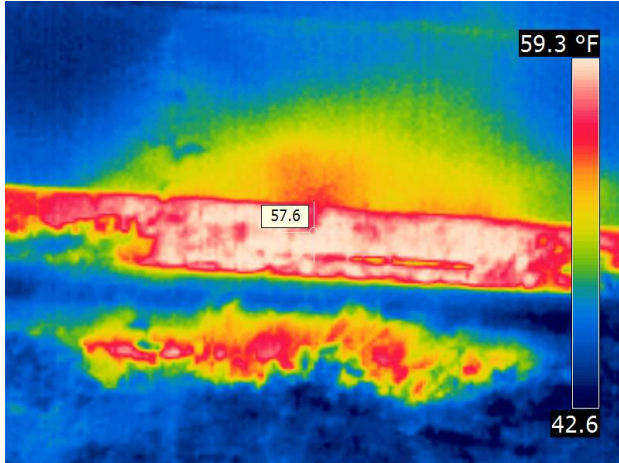
Description
Heatloss from the north facing window well.
